UNITED STATES COAST GUARD, FIRST DISTRICT
LIGHTHOUSE PROTECTION STUDIES, NEW ENGLAND

HIGHLAND LIGHT STATION
NORTH TRURO, MASSACHUSETTS

JULY 1988

HIGHLAND LIGHT STATION, NORTH TRURO, MA
EROSION STUDY

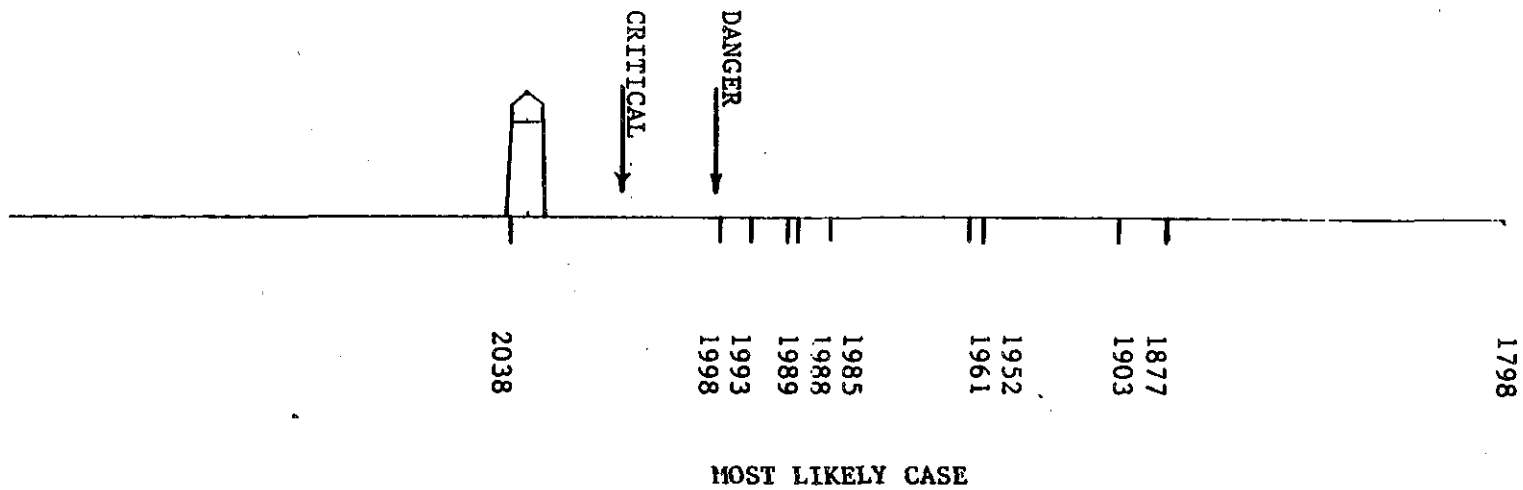
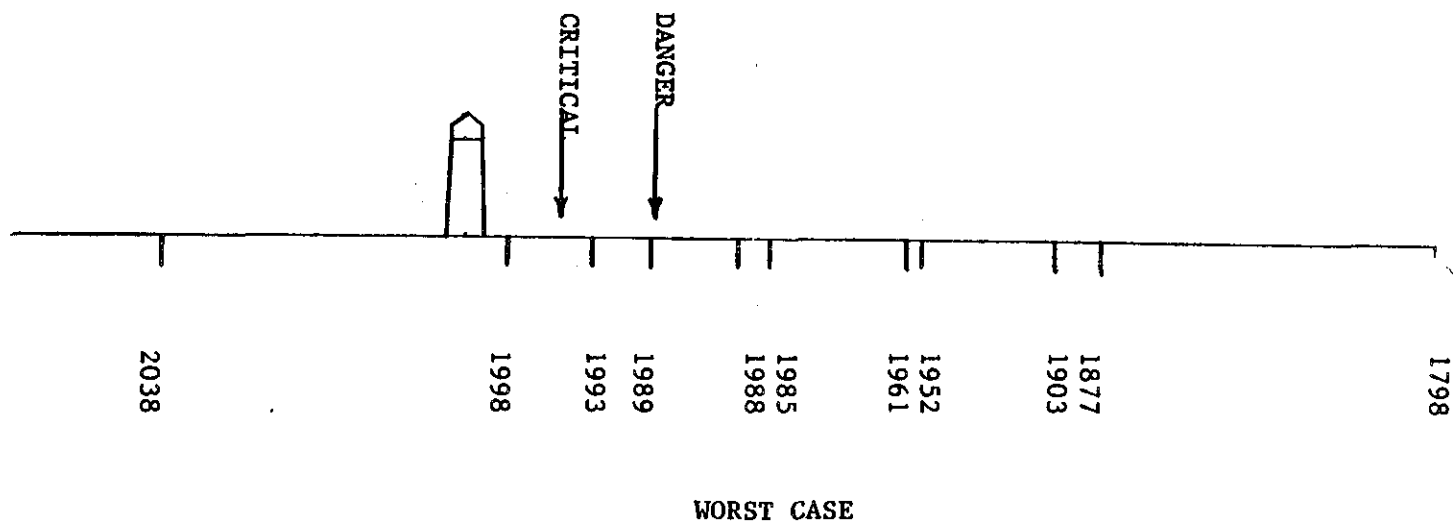
FIGURE 17 - PREDICTED CLIFF EDGE POSITIONS

From 1982 to 1986 the bluff retreated 20 feet, therefore it is estimated that the bluff will continue to erode at a rate of 5 feet per year next year and for the following 5 years. There are no obvious signs of imminent major failure of the bank. Highland Light is currently experiencing higher than average erosion. Since the average erosion over the last 190 years has been 1.9 feet per year the erosion rate over the next 50 years should decrease towards this value. The erosion rate over the next 10 years is predicted to decrease to an average of 4 feet per year. Since 1952 the bank has eroded at an average rate of 2.6 feet per year. By averaging, the erosion rate over the next 50 years comes to 3 feet per year.

Estimating the worst possible case is a bit more difficult. Obviously, the worst possible case is for the lighthouse to fall in the water today. This is possible but highly unlikely. The cliff in front of the lighthouse is 130 feet high and lies at an angle of about 40 degrees. If this reduces to the angle of repose of sand which is 33 degrees, 45 feet of bank would be lost. Remembering Thoreau's value of 40 feet lost in one season, the 1 year worst case is 45 feet. Gatto reported 15 feet per year of erosion for 3 years. He also states that some values in this area are suspect, but there were some high erosion rates reported over the years, therefore, we are assuming the "worst case" erosion over 5 years is 15 feet per year; over 10 years it is 12 feet per year; over 50 years it is 6 feet per year. These 10 and 50 year estimates are 3 and 2 times the most likely estimates respectively. Over time the worst case and most likely case estimates should approach each other since the variability of erosion rate becomes less of a factor.

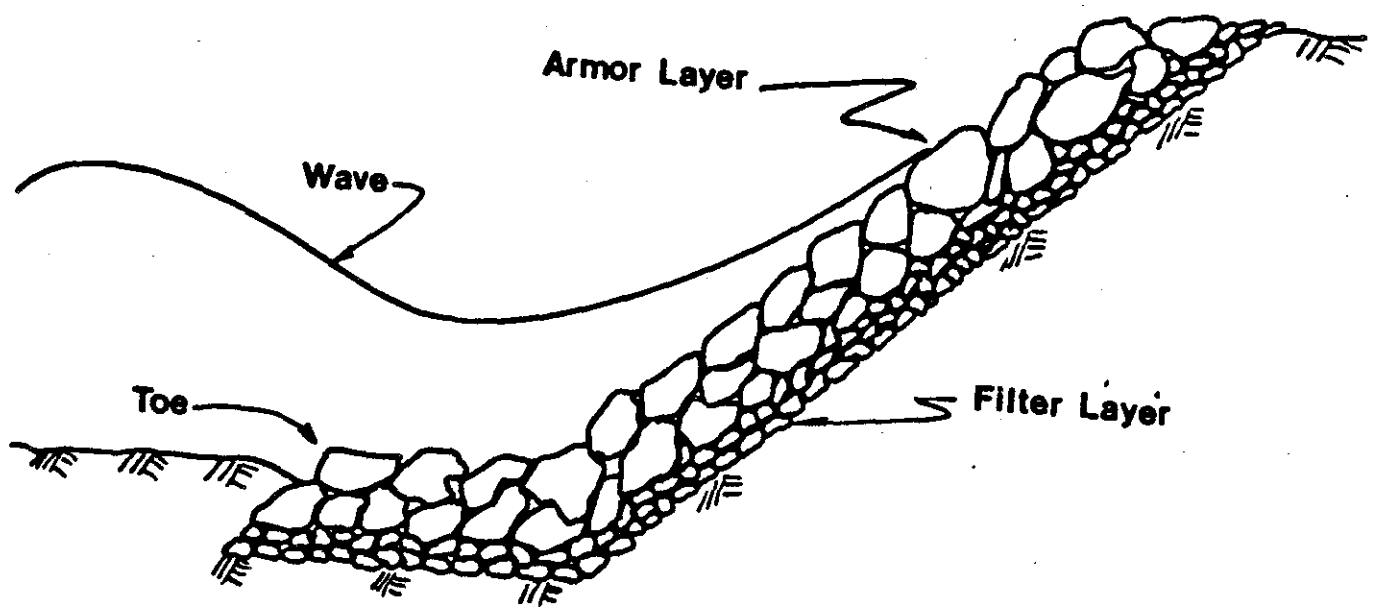
FIGURE 17-A TYPICAL REVETMENT SECTION

A detailed plan of a revetment suitable for the protection of Highland Light is beyond the scope of this report. For illustrative purposes, however, a typical cross section of a revetment is seen in figure 17-A. An analysis of the situation, suitable for general planning purposes only, supplies the following design data.

- a) deep water wave height (from SEAS data) of 20 feet
- b) estimated vertical run-up on rough quarry stone of 16 feet
- c) revetment slope of 1.0 V on 1.5 H
- d) armor layer thickness of 15 feet
underlayer thickness of 2 feet
bedding layer thickness of 1 foot
- e) cross section of structure is 850 square feet
- f) linear dimension of 800 feet (length of lighthouse property)
- g) volume of revetment using above dimensions is 680,000 ft³.
Assuming 25% voids and a rock density of 165 lbs/ft³ results in a weight of 45,000 tons
